## **Borrow Source *BS899*** **Geotechnical Data Report**

### **Mackenzie Valley Highway Project** **Sahtú Settlement Area, Northwest Territories**

PRESENTED TO  
**Government of the Northwest Territories**  
**K'alo-Stantec Limited**

SEPTEMBER 11, 2025  
ISSUED FOR USE  
FILE: 704-ENG.EARC03299-03

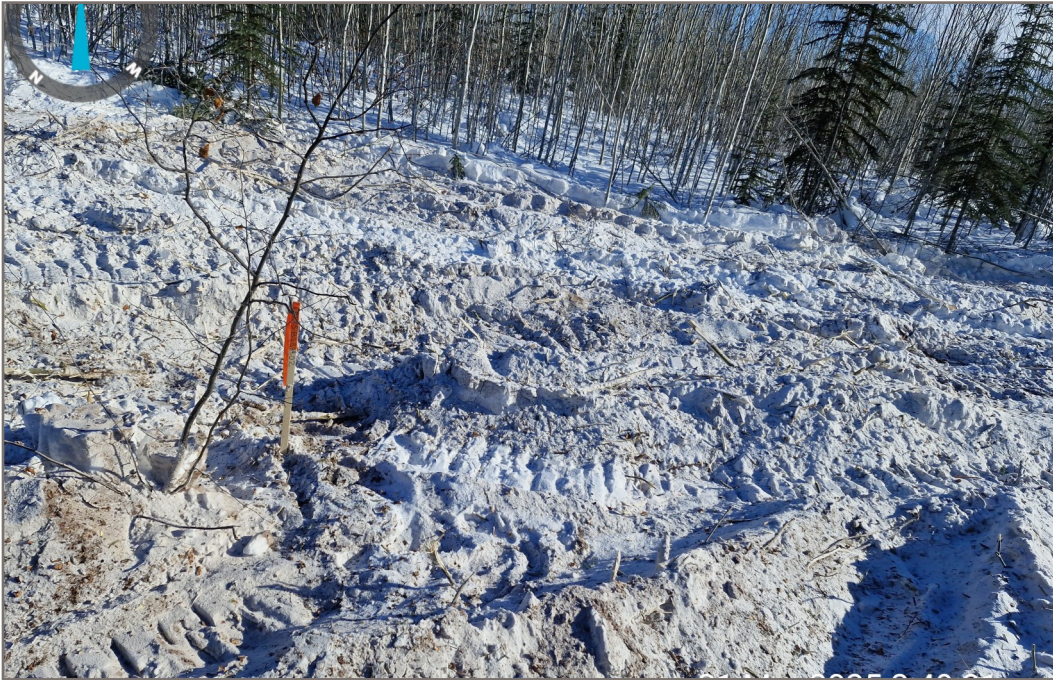
**Photo 1:** Borrow Source BS899, Site Access Clearing  
Site access clearing completed for Testpit *TP25-BS899-02*  
(Photo Date: March 21, 2025)

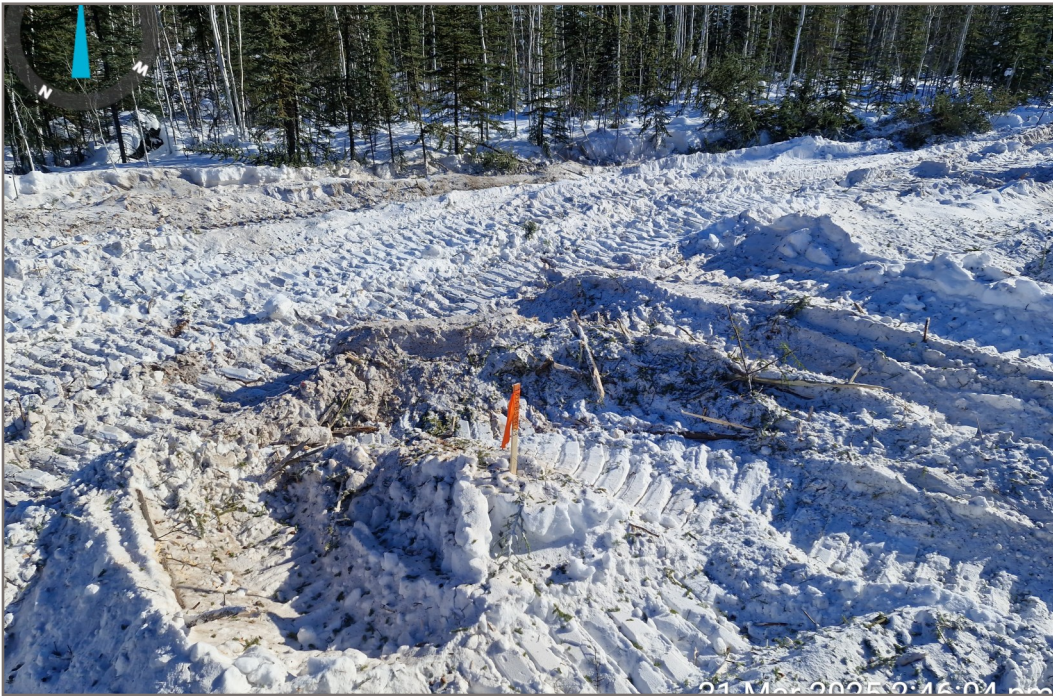
**Photo 2:** Borrow Source BS899, Site Access Clearing  
Site access clearing completed for Testpit *TP25-BS899-03*  
(Photo Date: March 21, 2025)

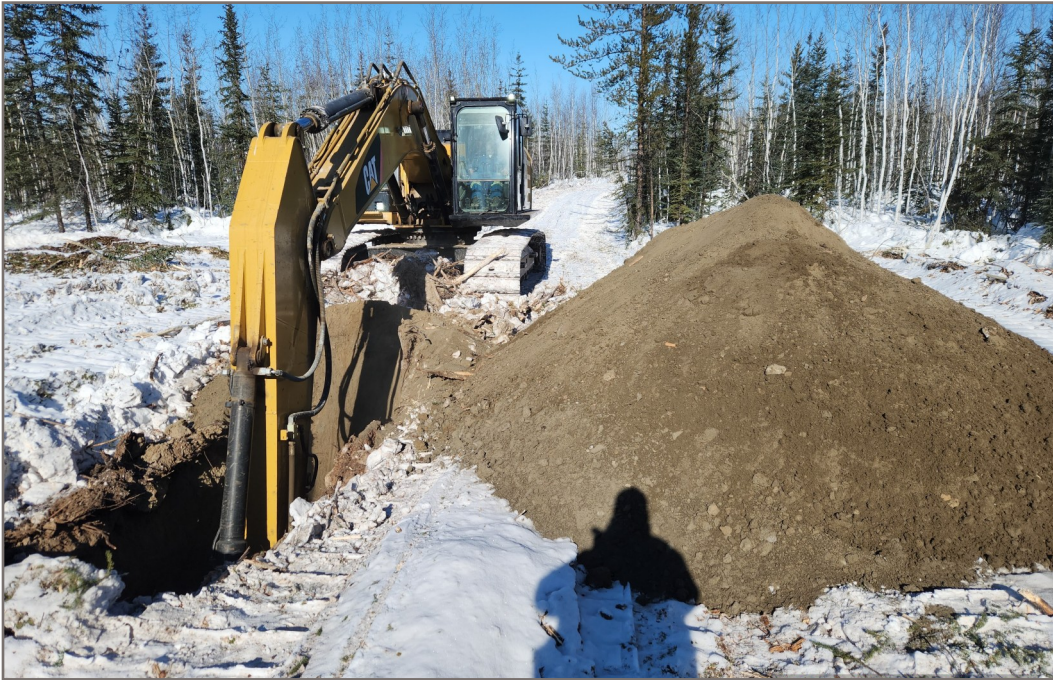
**Photo 3:** Borrow Source BS899, Testpit Excavating  
Excavating for Testpit *TP25-BS899-03*  
(Photo Date: March 26, 2025)

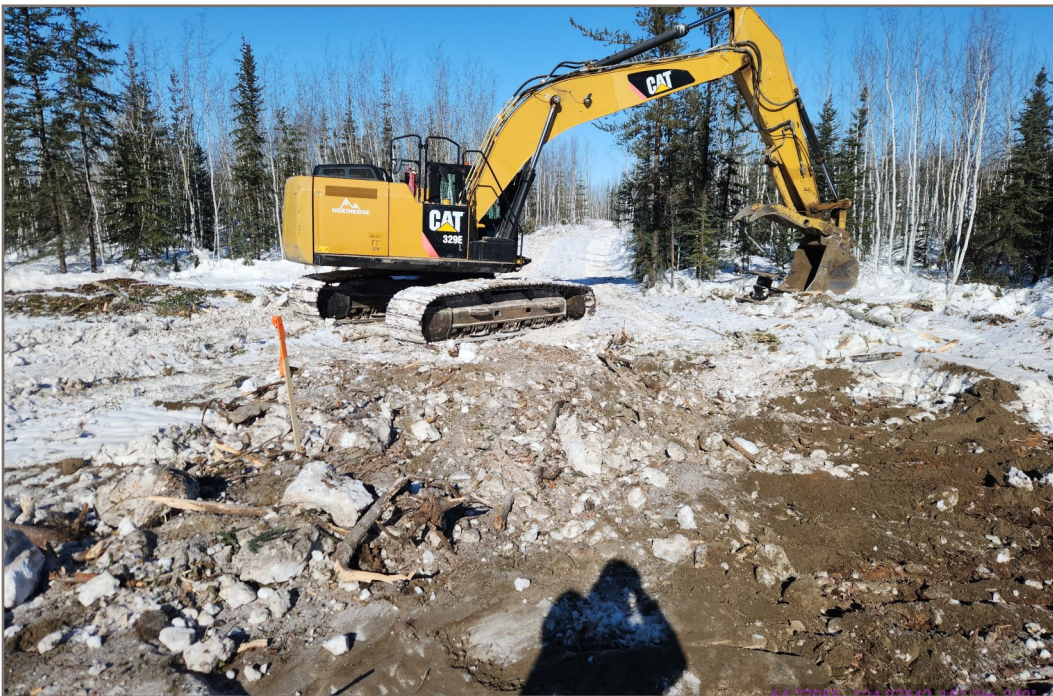
**Photo 4:** Borrow Source BS899, Testpit Excavating  
Completed and backfilled Testpit *TP25-BS899-03*  
(Photo Date: March 26, 2025)

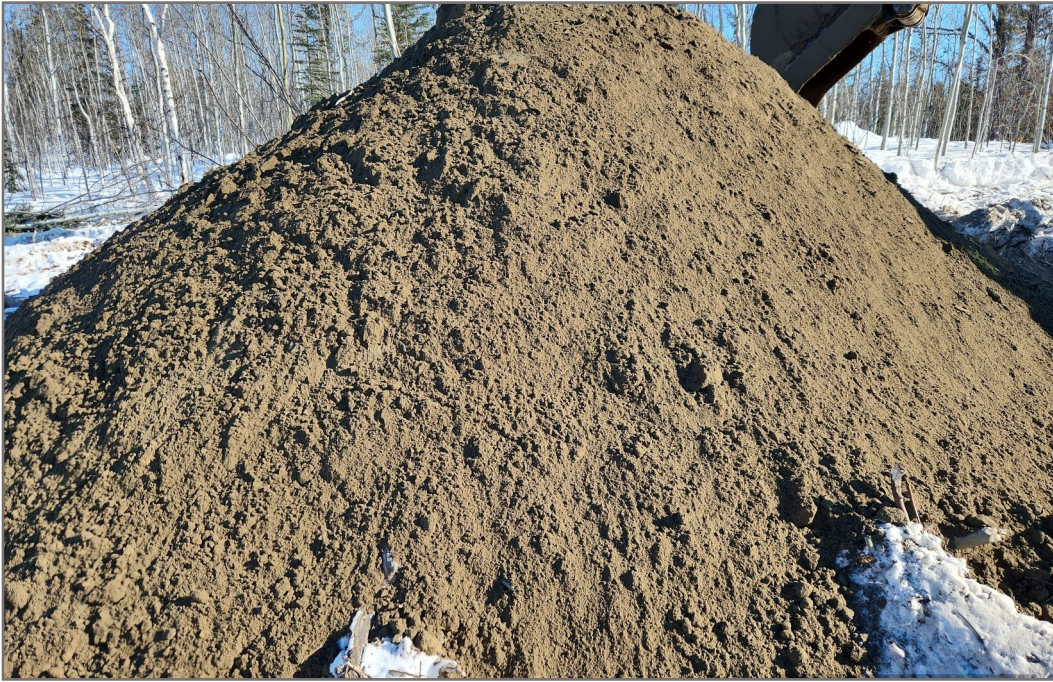
**Photo 5:** Borrow Source BS899, Testpit *TP25-BS899-01*  
Fine-Grained Sand recovered from Testpit *TP25-BS899-01*  
(Photo Date: March 26, 2025)

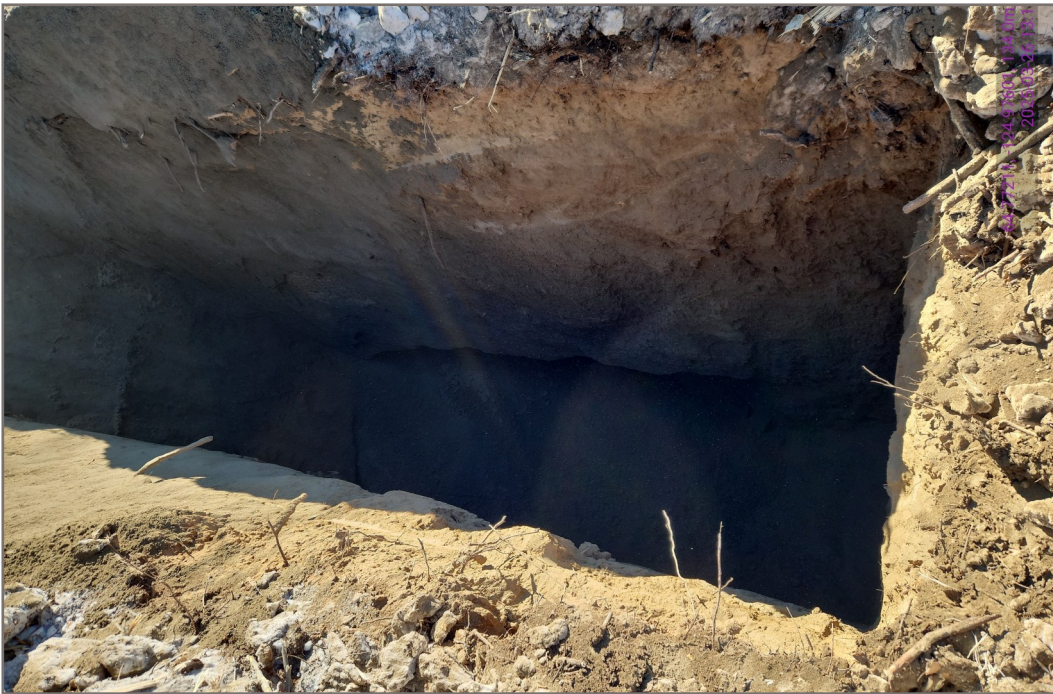
**Photo 6:** Borrow Source BS899, Testpit *TP25-BS899-01*  
Fine-Grained Sand observed in Testpit *TP25-BS899-01*  
(Photo Date: March 26, 2025)

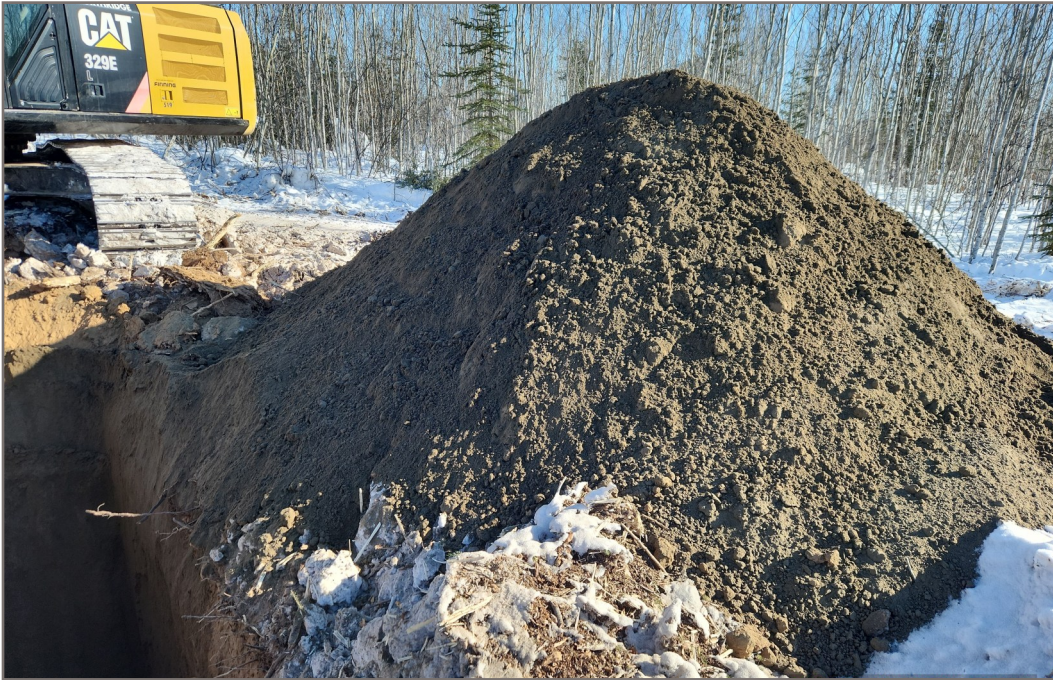
**Photo 7:** Borrow Source BS899, Testpit *TP25-BS899-02*  
Fine-Grained Sand recovered from Testpit *TP25-BS899-02*  
(Photo Date: March 26, 2025)

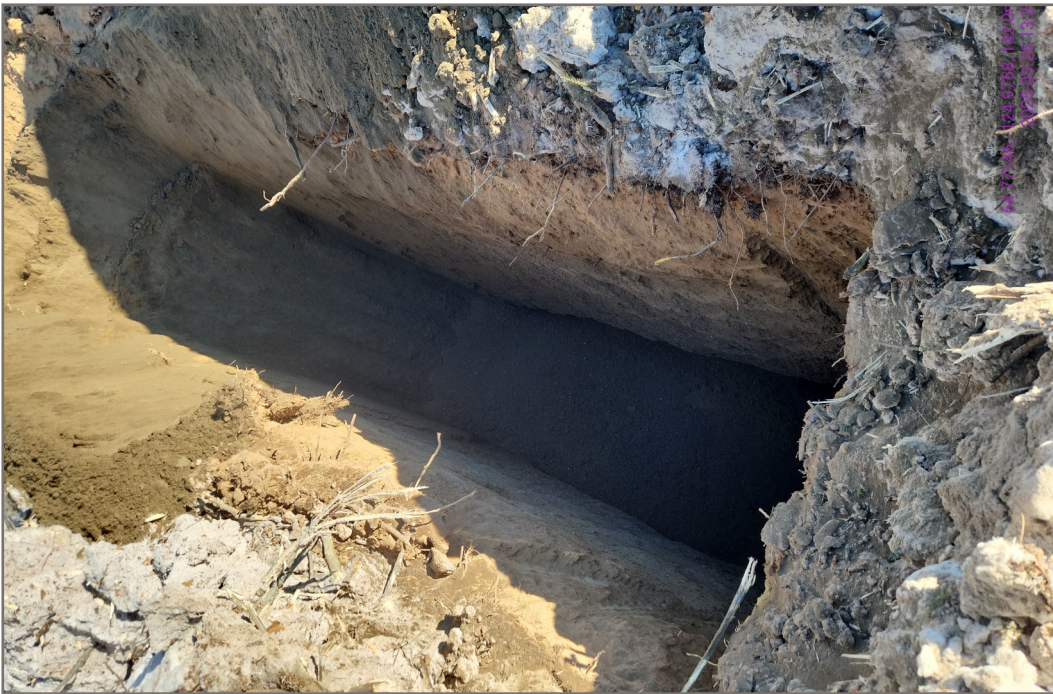
**Photo 8:** Borrow Source BS899, Testpit *TP25-BS899-02*  
Fine-Grained Sand observed in Testpit *TP25-BS899-02*  
(Photo Date: March 26, 2025)

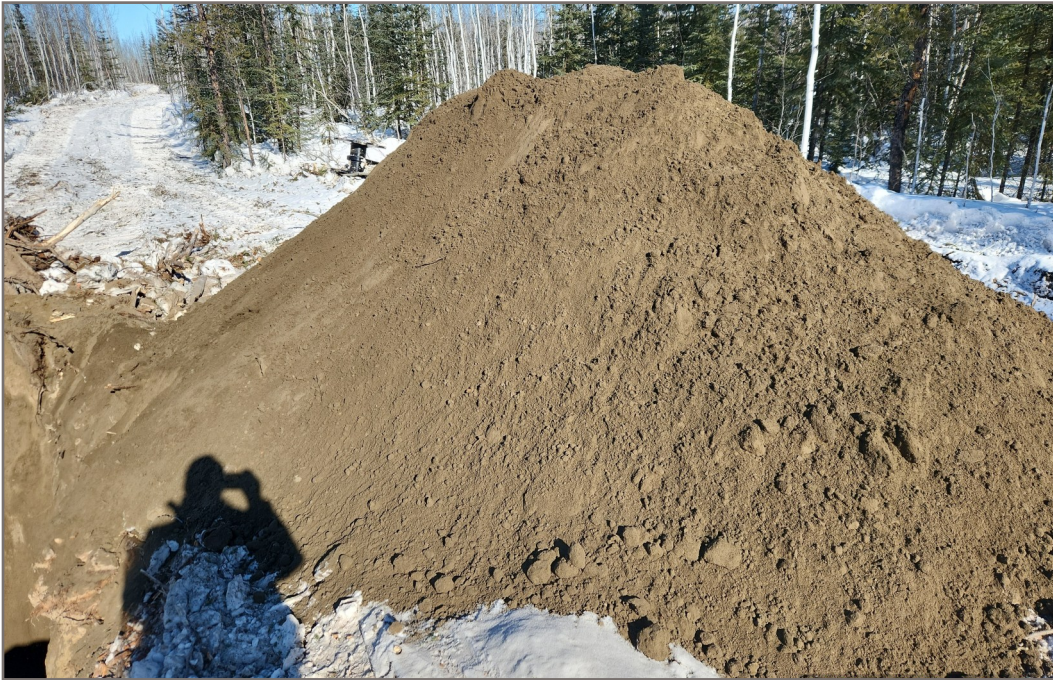
**Photo 9:** Borrow Source BS899, Testpit *TP25-BS899-03*  
Fine-Grained Sand recovered from Testpit *TP25-BS899-03*  
(Photo Date: March 26, 2025)

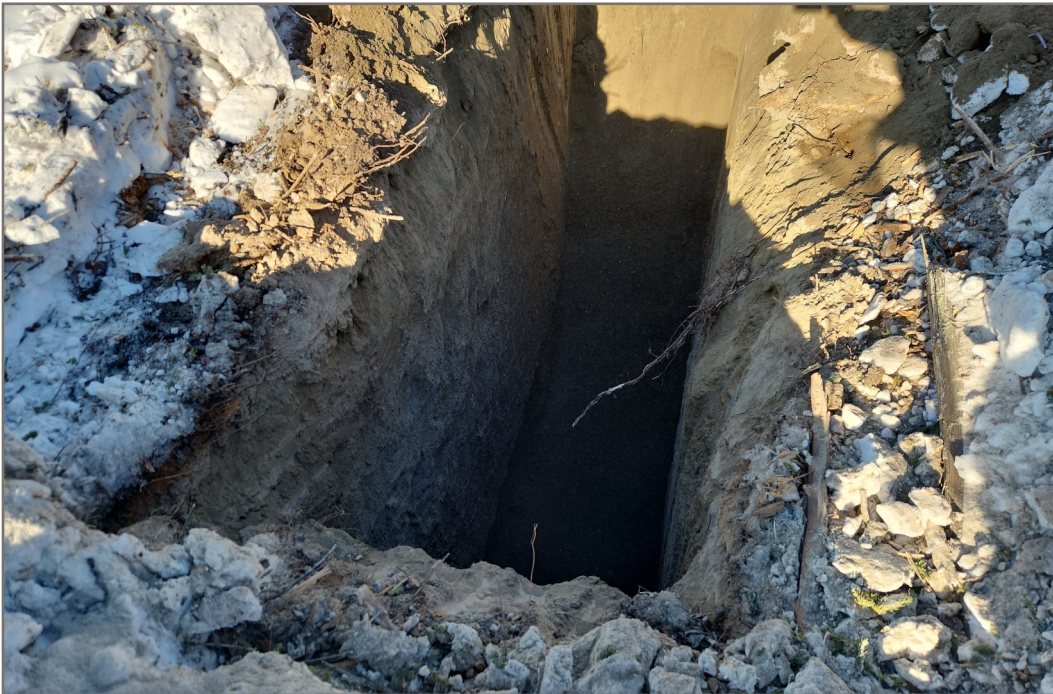
**Photo 10:** Borrow Source BS899, Testpit *TP25-BS899-03*  
Fine-Grained Sand observed in Testpit *TP25-BS899-03*  
(Photo Date: March 26, 2025)

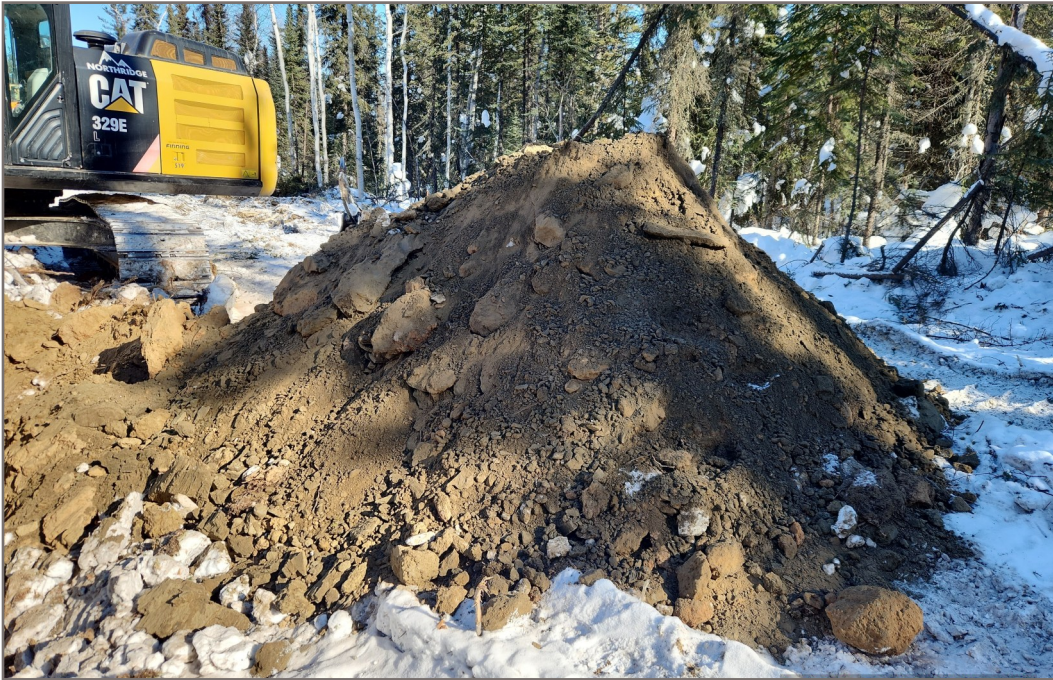
**Photo 11:** Borrow Source BS899, Testpit *TP25-BS899-04*  
Fine-Grained Sand recovered from Testpit *TP25-BS899-04*  
(Photo Date: March 26, 2025)

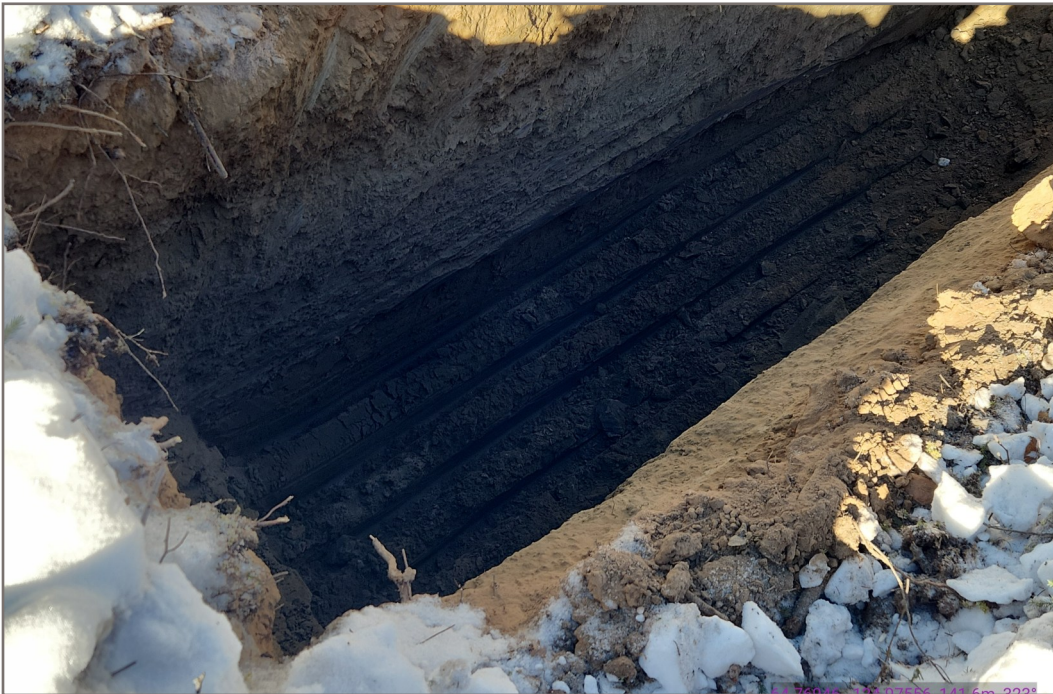
**Photo 12:** Borrow Source BS899, Testpit *TP25-BS899-04*  
Fine-Grained Sand observed in Testpit *TP25-BS899-04*  
(Photo Date: March 26, 2025)

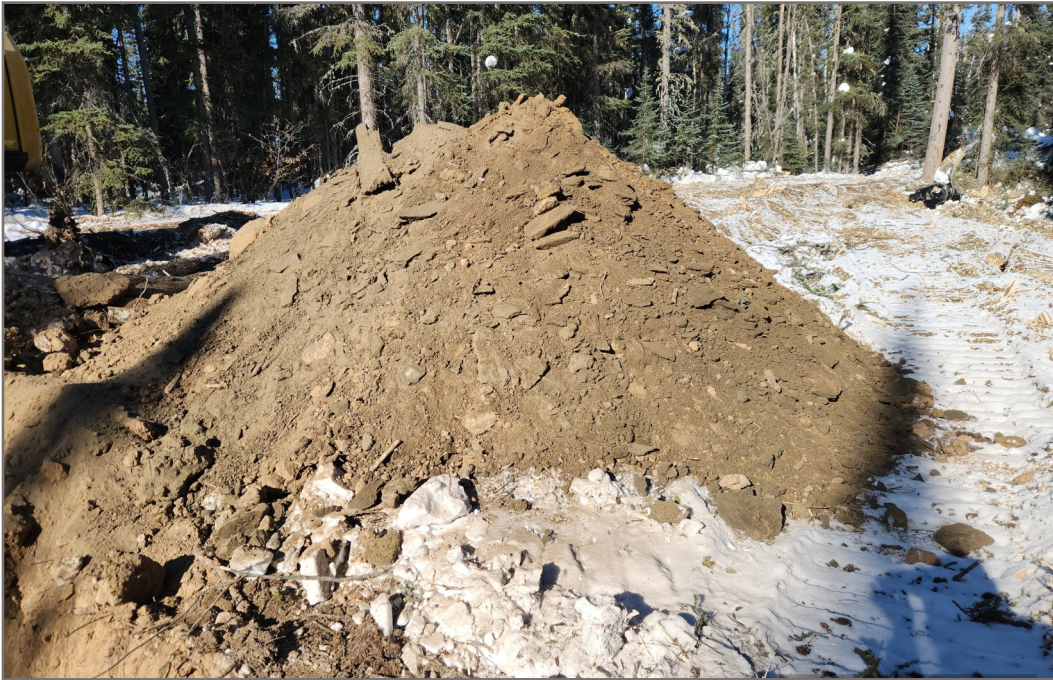
**Photo 13:** Borrow Source BS899, Testpit *TP25-BS899-05*  
Fine-Grained Sand recovered from Testpit *TP25-BS899-05*  
(Photo Date: March 26, 2025)

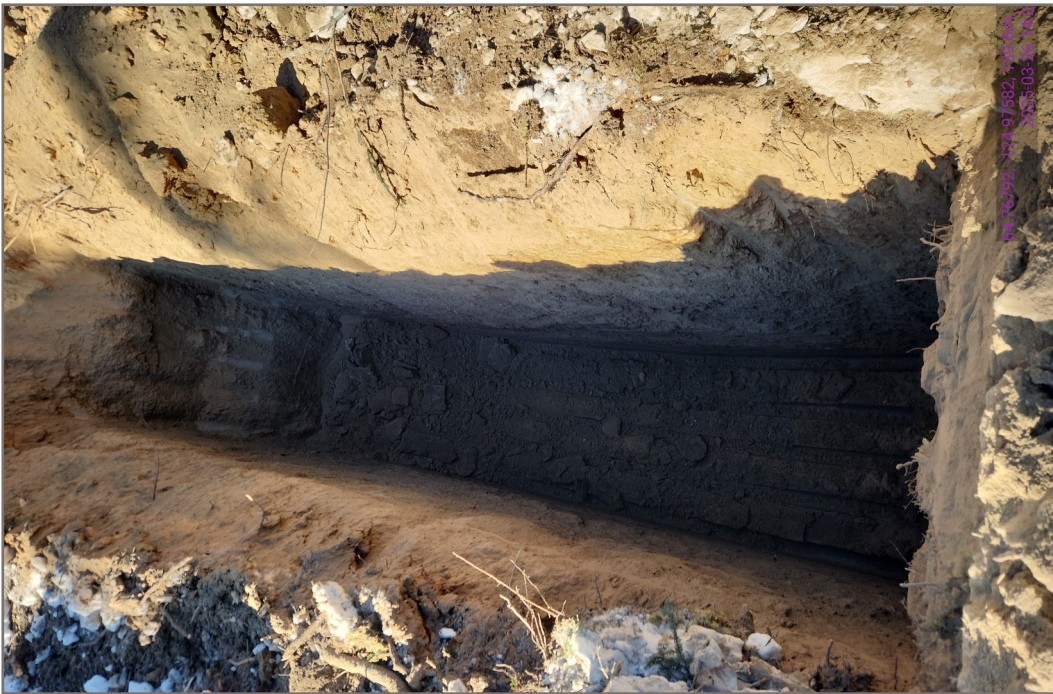
**Photo 14:** Borrow Source BS899, Testpit *TP25-BS899-05*  
Fine-Grained Sand observed in Testpit *TP25-BS899-05*  
(Photo Date: March 26, 2025)
